North Providence Schools Facility Study

Stage I

January 16, 2014

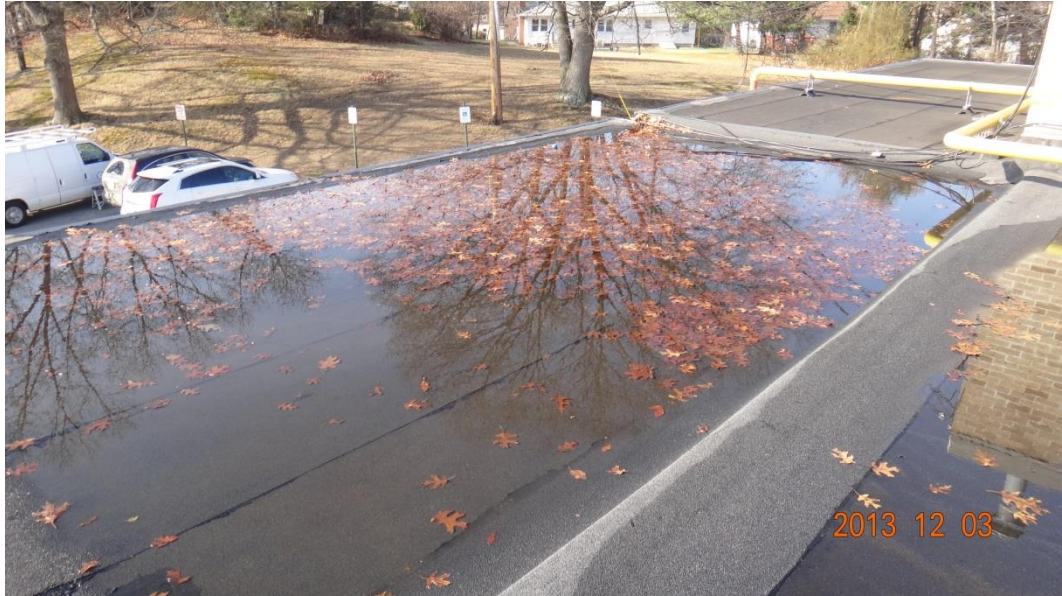
1. Water is ponding on the roofs of the buildings at several locations. (Please refer to the Photos #1 to #3 below.) **Comments and Recommendations:** *Although there was no visual evidence of structural distress, ponding of water on the roof of a building can cause the roof structure to sag due to the weight of the water. As the roof sags, more water can become entrapped in the low spot of the roof, causing additional sagging. The roof structure should be adequately pitched, or tapered insulation below the roof membrane must be installed, to allow the water to flow to the roof drains.*

PHOTO #1 – This photograph shows the water ponding on the canopy roof at the front entrance to the school building.

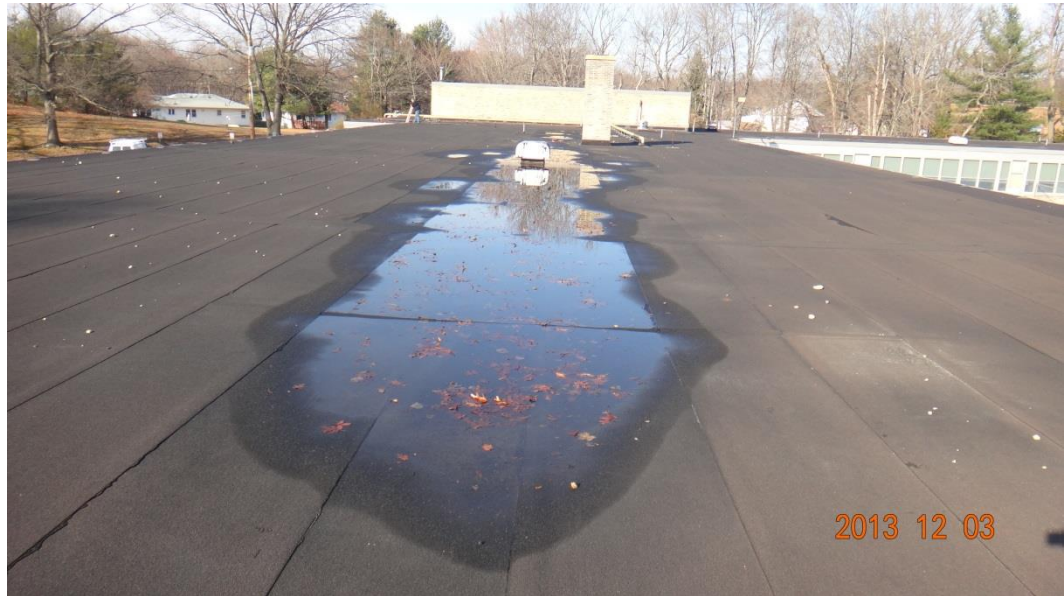
PHOTO #3 – *This photograph shows the water ponding on the roof of the southeast wing of the building.*

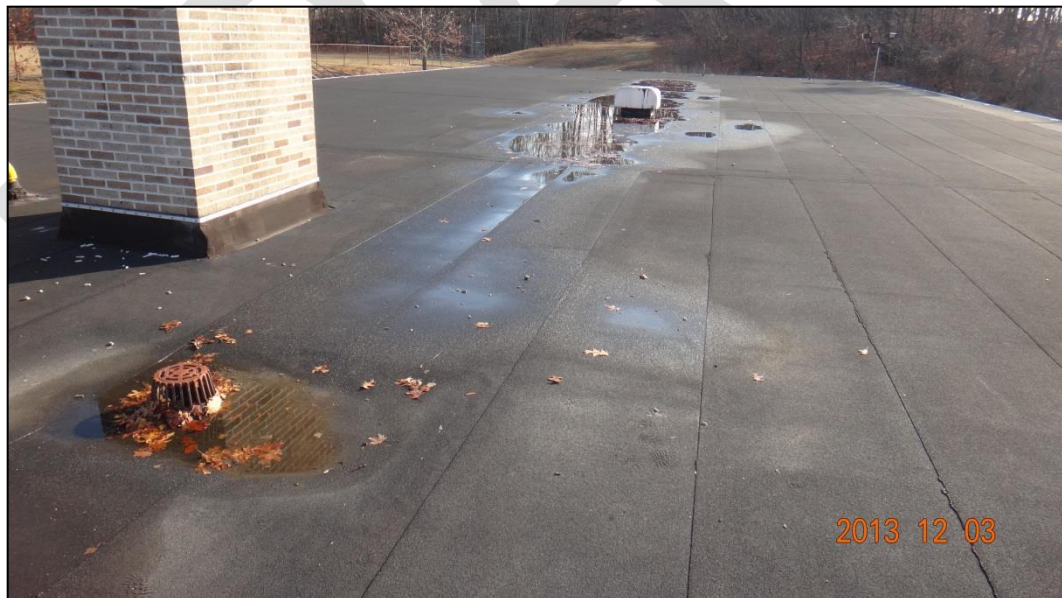
2. Some of the roof drains on the school building roofs have been purposefully blocked or have become partially blocked with debris. (Refer to Photo #4 below.) **Comments and Recommendations:** *All roof drains should be in a fully operation condition and must be cleared of debris on a regularly scheduled basis.*

PHOTO #4 – *This photograph shows one of the partially blocked drains on the roof of the Centredale Elementary School building.*

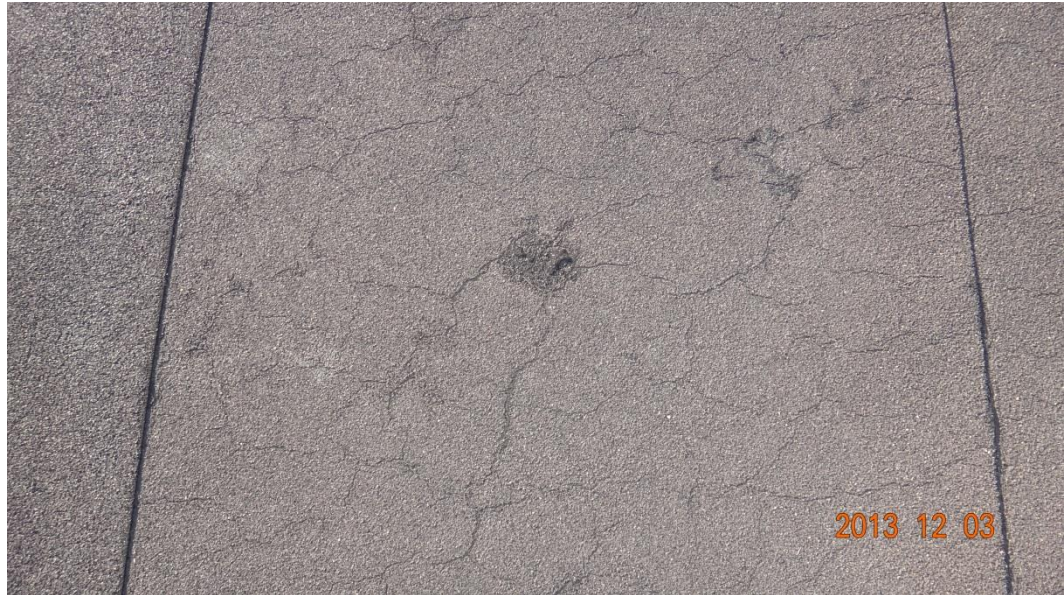
3. The rolled asphalt sheet roofing system on the roof of the Centredale Elementary School appears to be reaching the end of its useful life. The exposed surface of the asphalt sheets was cracked and blistered; "fish mouths" were observed along the seam joints; and bubbles had formed under the asphalt sheets. (Please refer to the Photos #5 to #7 below.) **Comments and Recommendations:** *A roofing consultant should be hired to appraise the condition of the roof.*

PHOTO #5 – *This photograph shows the cracking and blistering of the rolled asphalt sheet roofing on the Centredale Elementary School building.*

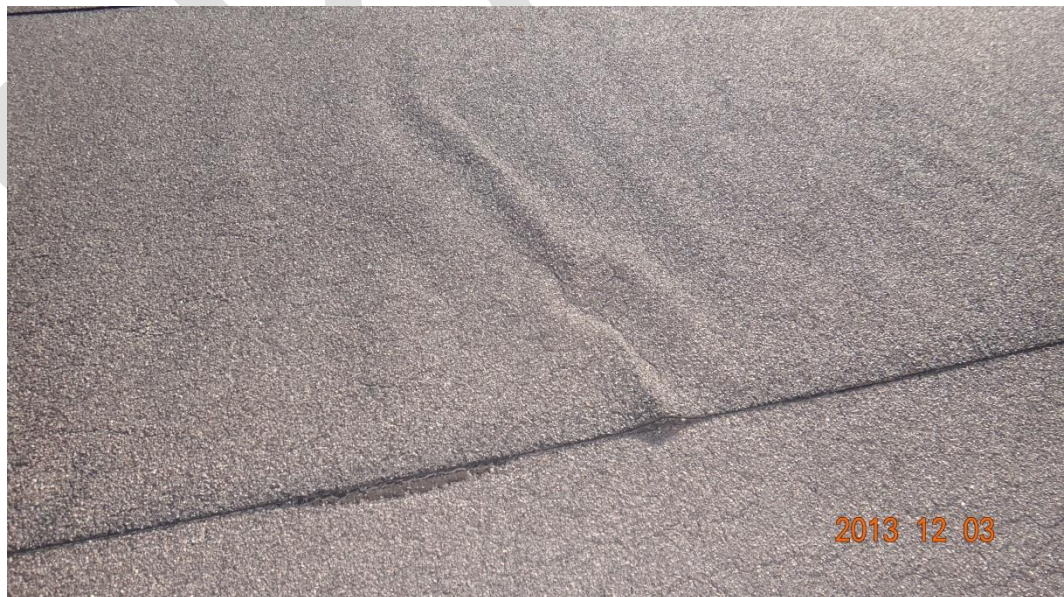
PHOTO #6 – *This photograph shows one of the "fish mouths" along one of the rolled roofing sheet joints.*

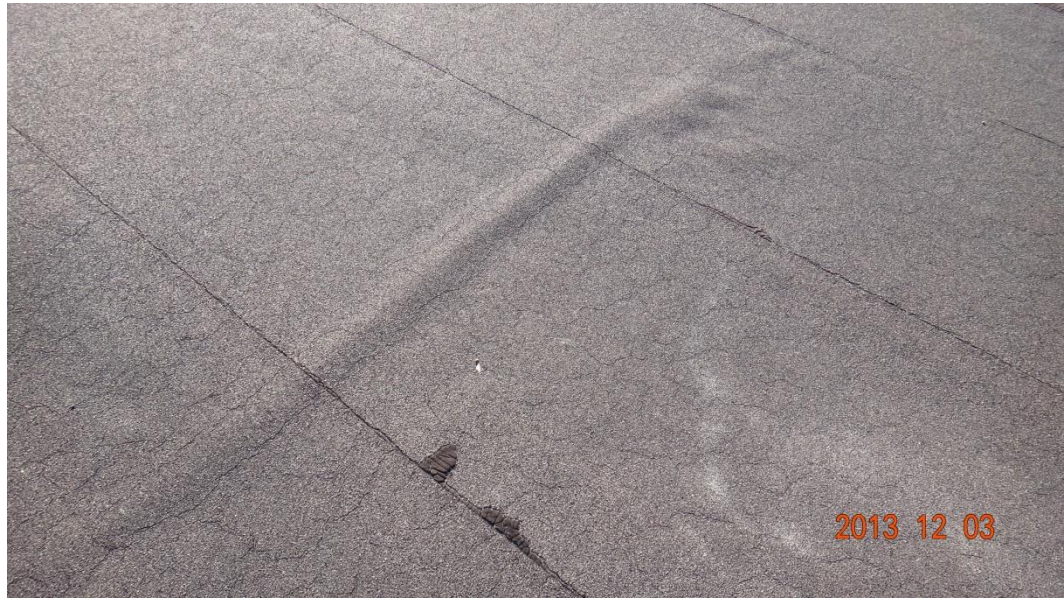
PHOTO #7 – *This photograph shows the cracking of the surface and the bubble under the rolled asphalt sheet roofing.*

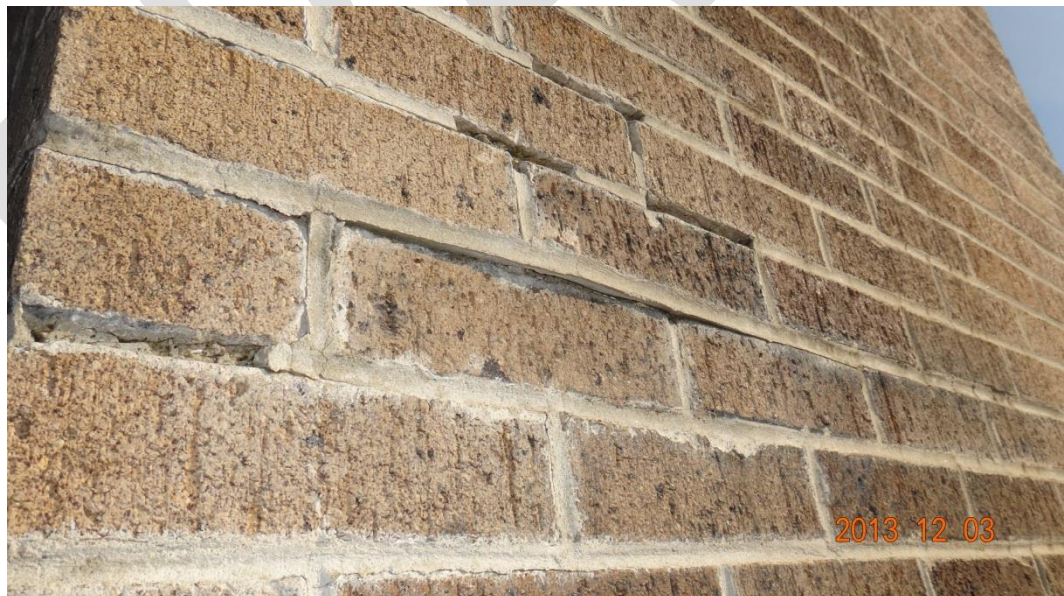
4. Some of the brick mortar joints in the Boiler Room chimney extending above the roof of the building have deteriorated. (Please refer to the Photos #8 and #9 below.)
Comments and Recommendations: *The deteriorated chimney brick mortar joints should be raked and repointed to assure the long-term performance of the chimney.*

PHOTO #8 – *This photograph shows some of the chimney brick mortar joints that require repointing.*

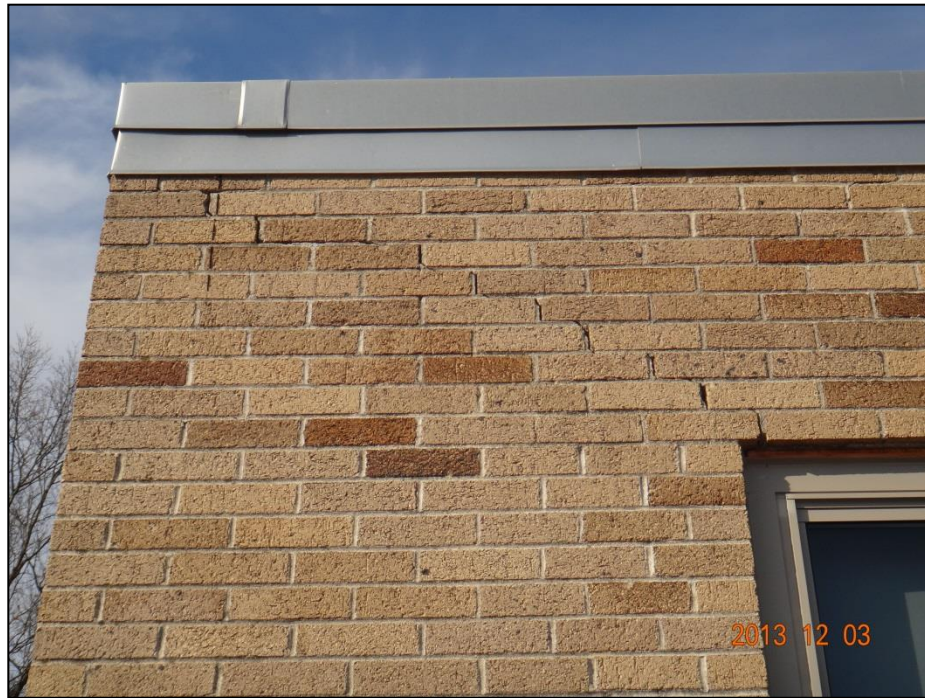
1. At several isolated locations, typically at the ends of the long, continuous exterior walls, the brick veneer is cracked. (Please refer to the Photos #1 to #3 below.) **Comments and Recommendations:** *These cracks appear to be caused by a lack of control joints to allow the brick veneer to freely expand and contract due to dimensional changes caused by variations in the temperature and moisture content of the brick. Odeh Engineer recommends that these cracks in the brick veneer be repaired, including the creation of new brick veneer control joints, so as to assure the long-term performance of the building envelope.*

PHOTO #1 – *This photograph shows the stepped cracking of the brick veneer near the end and at the top of the exterior wall.*

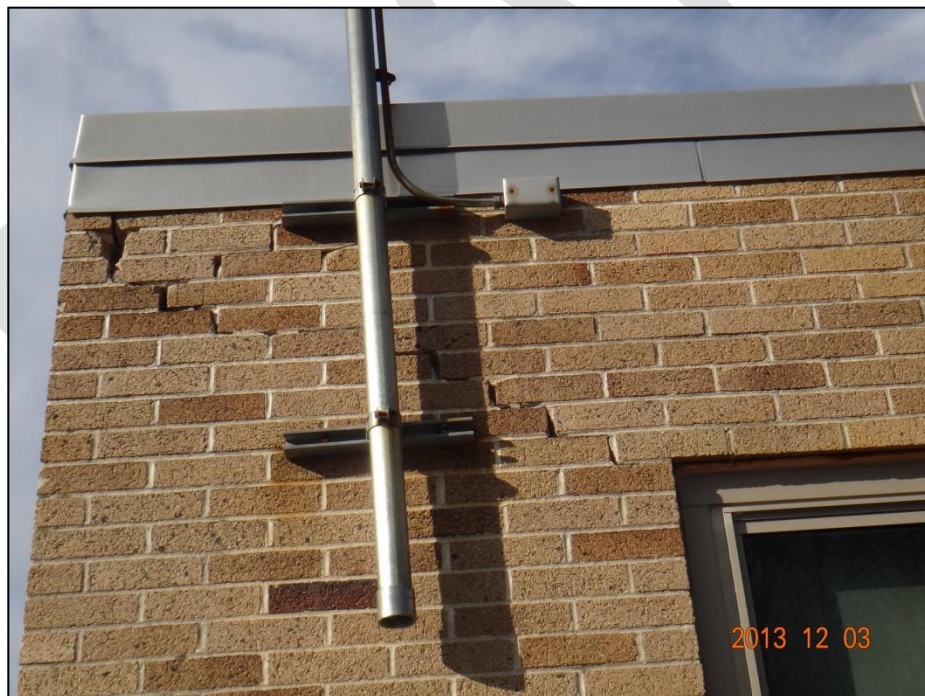
PHOTO #2 – *This photograph shows another location where the brick veneer has cracked at the top of the exterior wall. The cracks have occurred near the end of a long, continuous length of wall. There are no control joints to allow the brick veneer to freely expand and contract.*

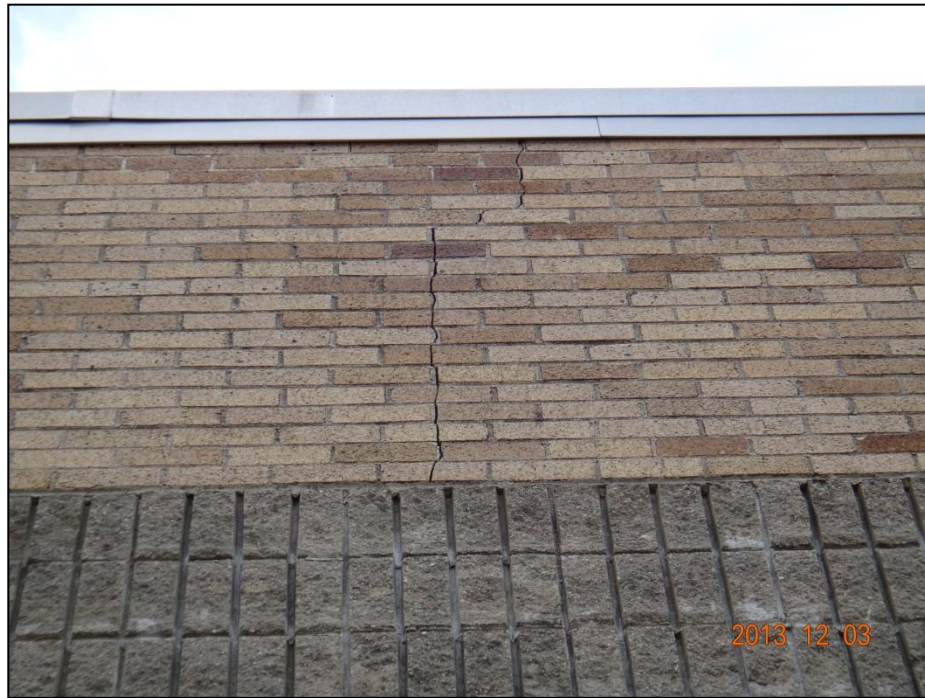
PHOTO #3 – *This photograph shows another location where a crack in the exterior brick veneer has occurred. This crack is located near the top of the exterior wall of the gymnasium building. There are no control joints in this length of wall.*

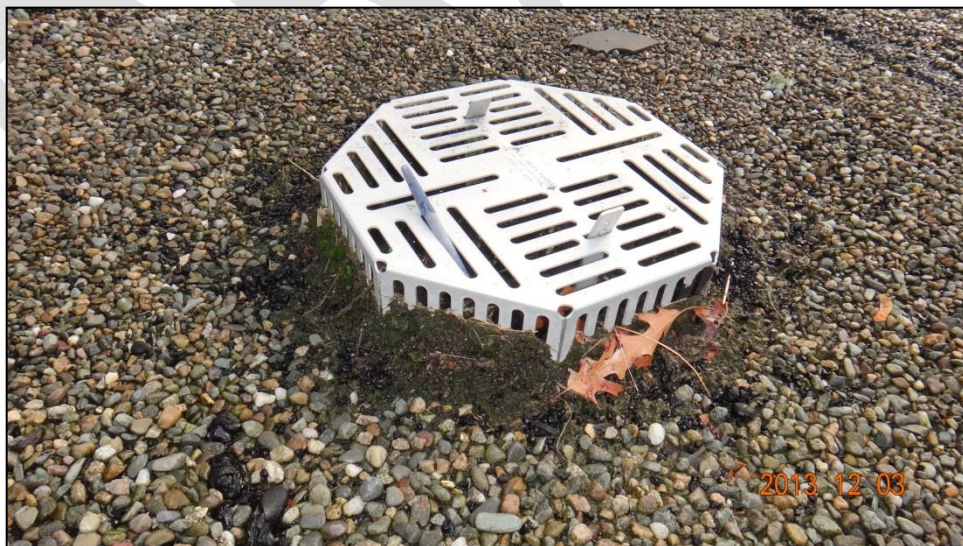
2. A couple of the roof drains on the school building roofs are partially blocked with debris. (Refer to Photo #4 below.) **Comments and Recommendations:** *All roof drains should be cleared of debris on a regularly scheduled basis.*

PHOTO #4 – *This photograph shows one of the partially blocked drains on the roof of the Greystone Elementary School building.*

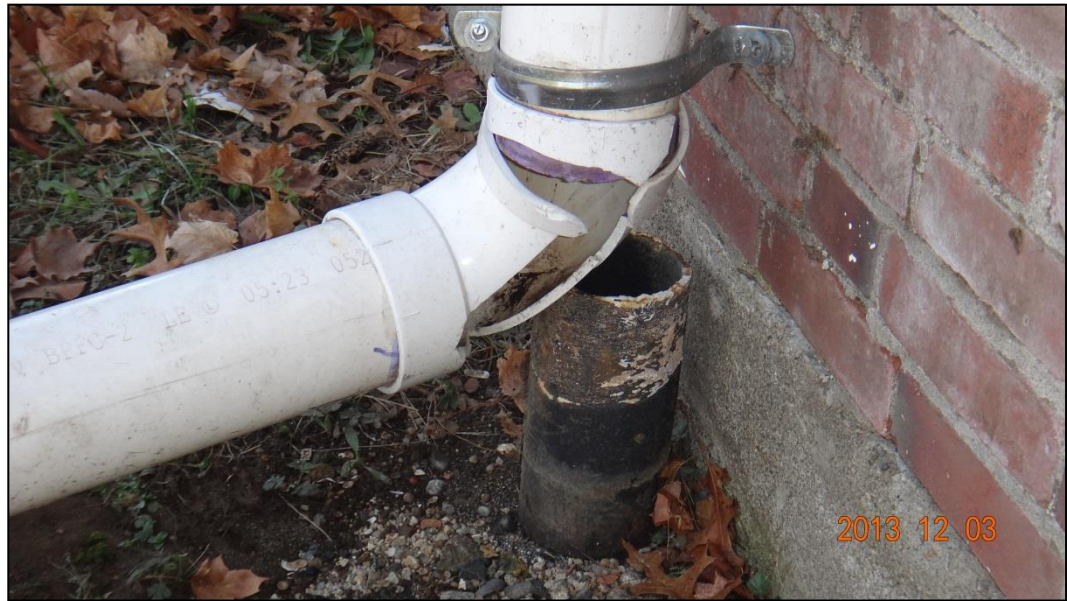
PHOTO #1 – *This photograph shows the damaged roof drain downspout located along the northeast side of the school building.*

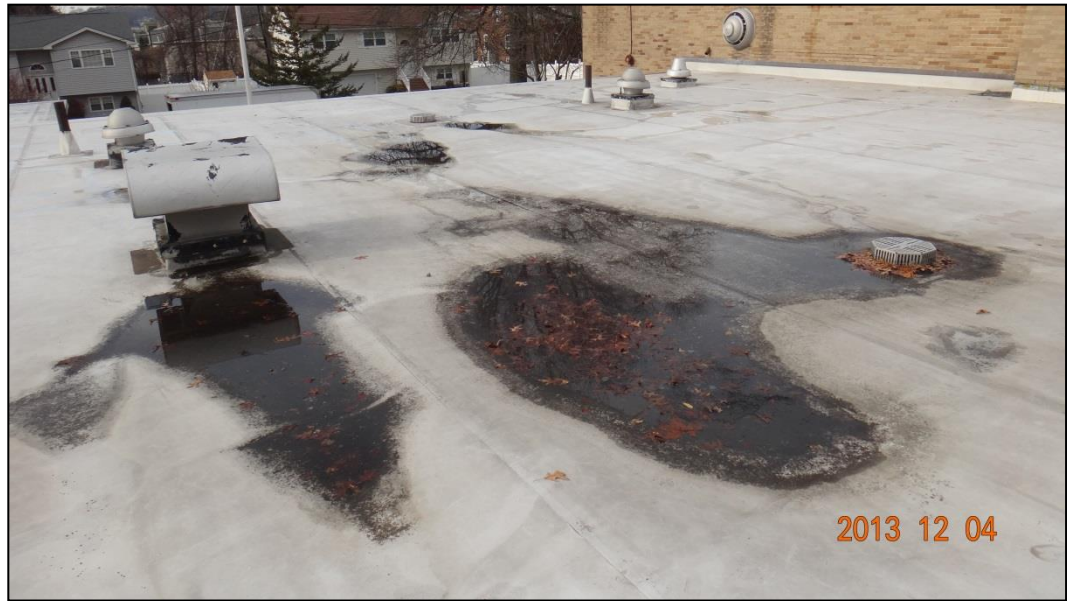
PHOTO #1 – *This photograph shows one of the areas where the water is ponding on the flat roofs of the Dr. Joseph A. Whelan Elementary School building.*

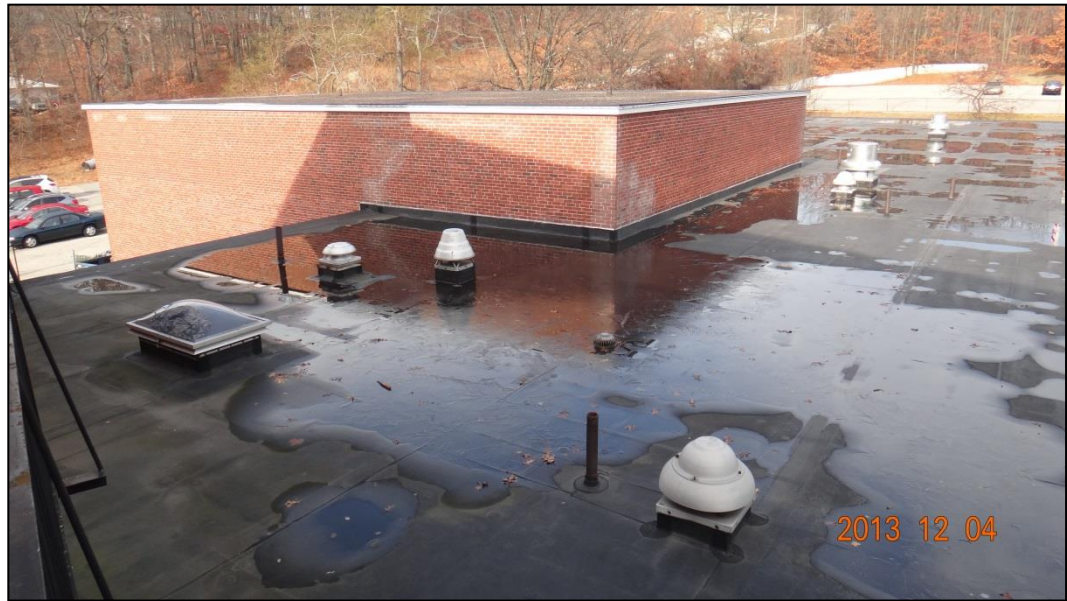
PHOTO #1 – *This photograph shows the water ponding on the flat roof of the Marieville Elementary School building.*

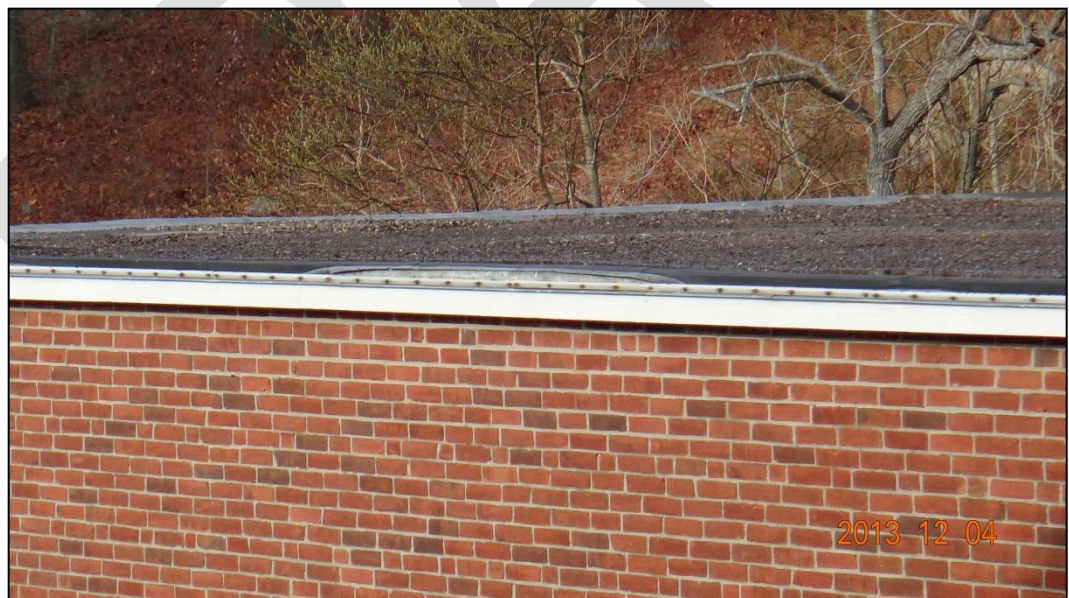
PHOTO #2 – *This photograph shows the edge of the rubber roofing membrane having become detached from the termination bar fastened to the wood fascia board located along the south side of the Marieville Elementary School gym roof.*

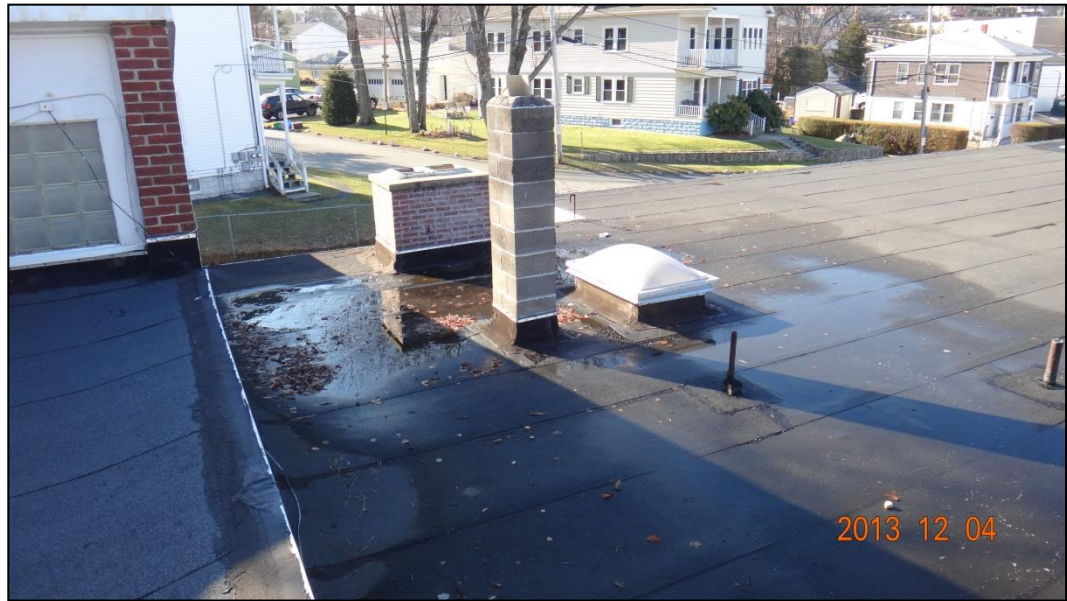
PHOTO #1 – *This photograph shows one of the areas where the water is ponding on the flat roof of the northwest wing of the Stephen Olney Elementary School building.*

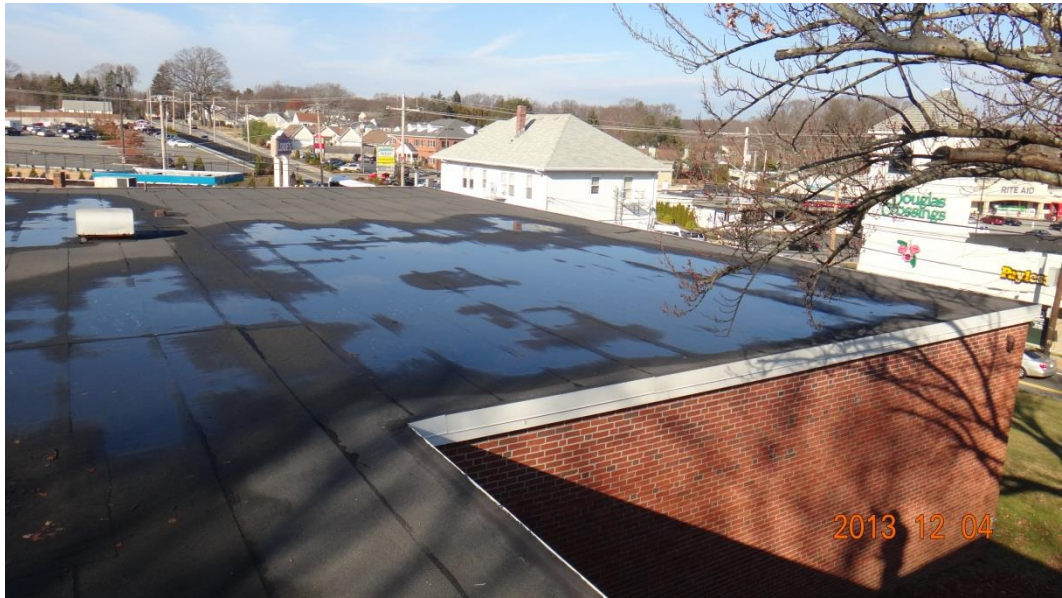
PHOTO #3 – *This photograph shows another location where water is ponding on the roof of the northwest wing of the school building.*

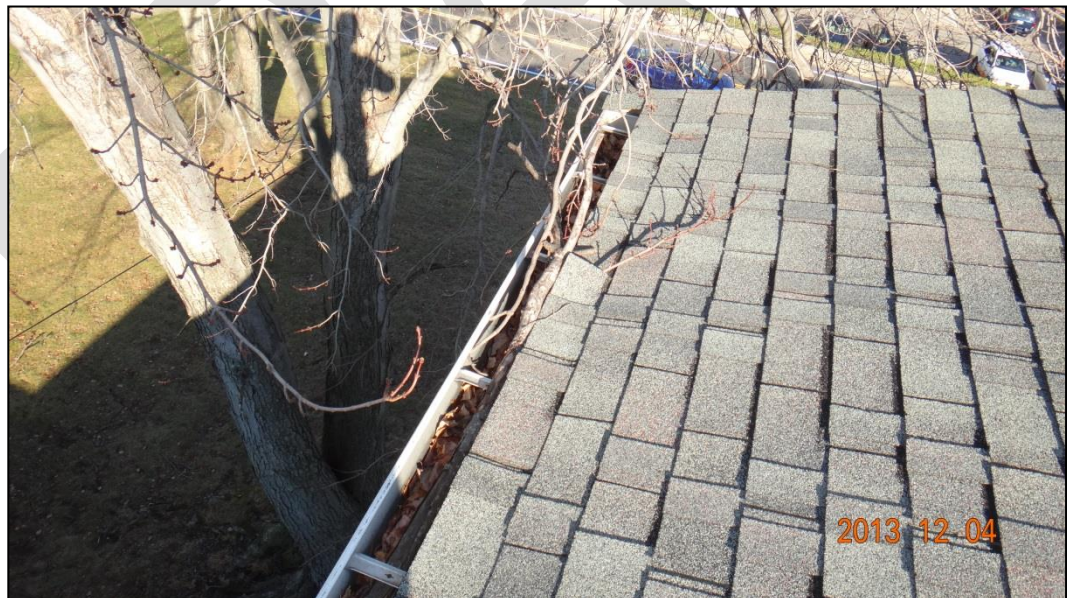
PHOTO #4 – *This photograph shows the leaves, branches and debris clogging the gutter on the sloped roof of the Stephen Olney Elementary School Gymnasium/Cafeteria building.*

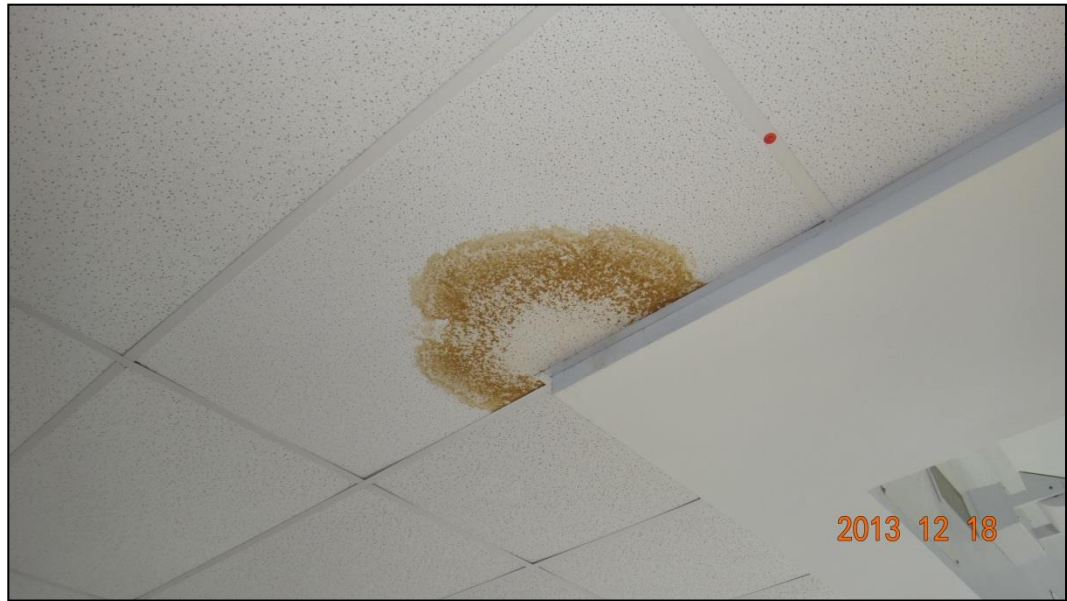
PHOTO #1 – *This photograph shows the water-staining of the acoustical ceiling tile in the foyer at the main entrance to the Dr. Edward A. Ricci Middle School building.*

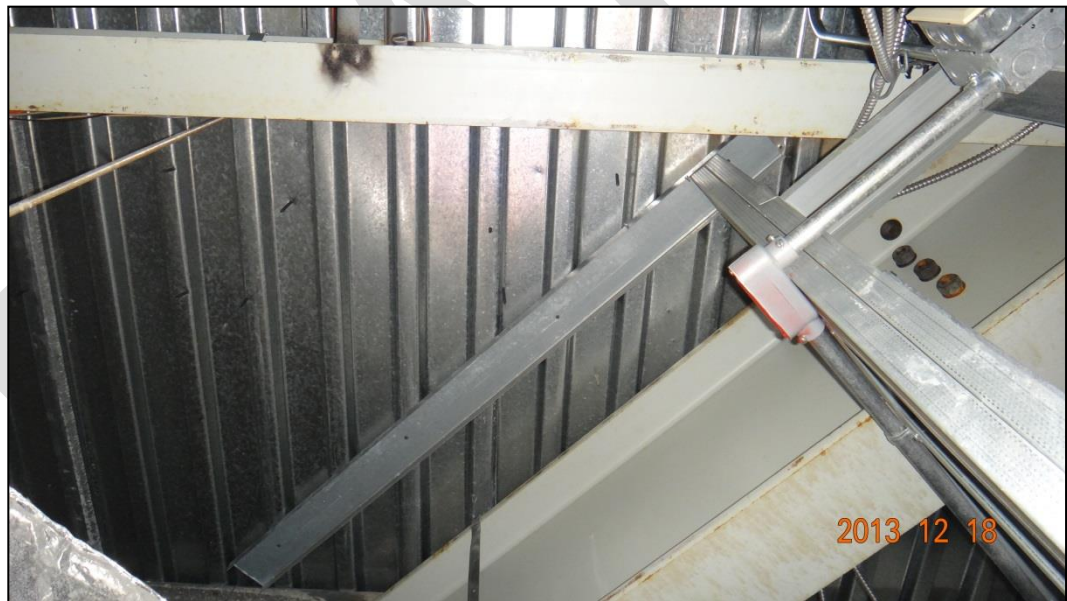
PHOTO #2 – *This photograph shows the good condition of the steel roof framing above the location of the roof leak in the foyer at the main entrance to the school building.*

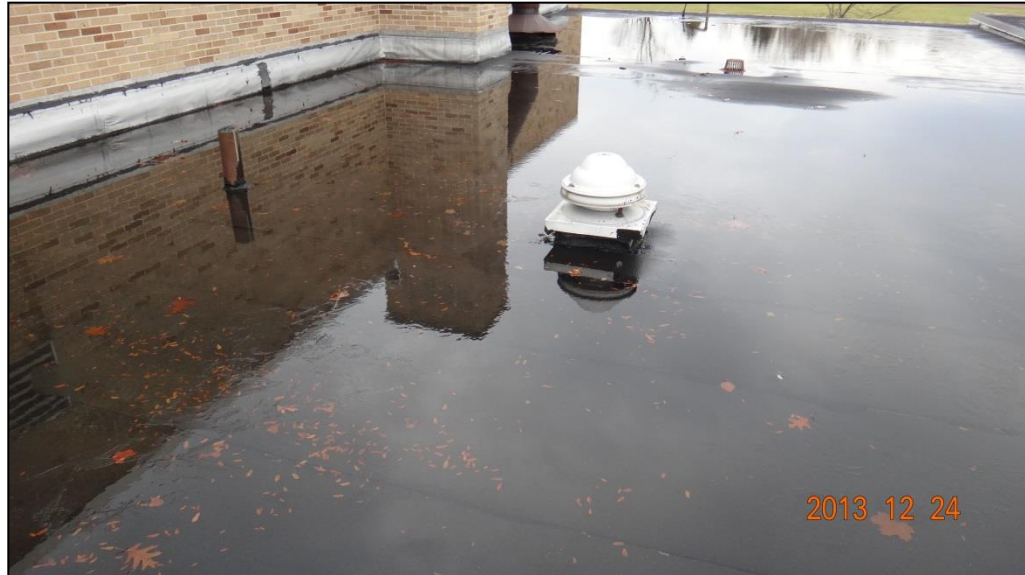
PHOTO #3 – *This photograph shows the ponding of water on the flat roof adjacent to the cafeteria at the Ricci Middle School building.*

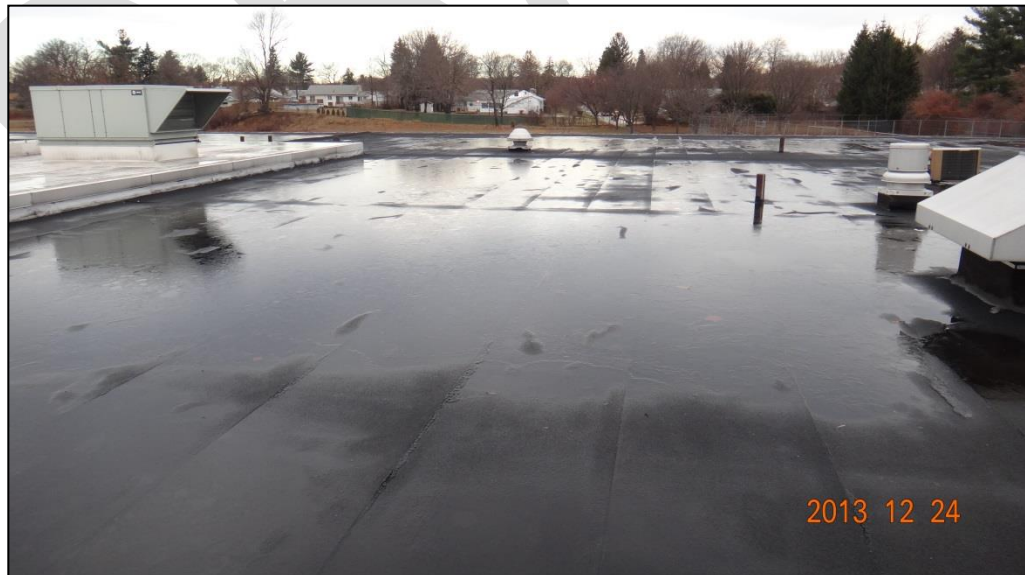
PHOTO #4 – *This photograph shows the ponding of water on the flat roof near the eastern end of the Ricci Middle School building.*

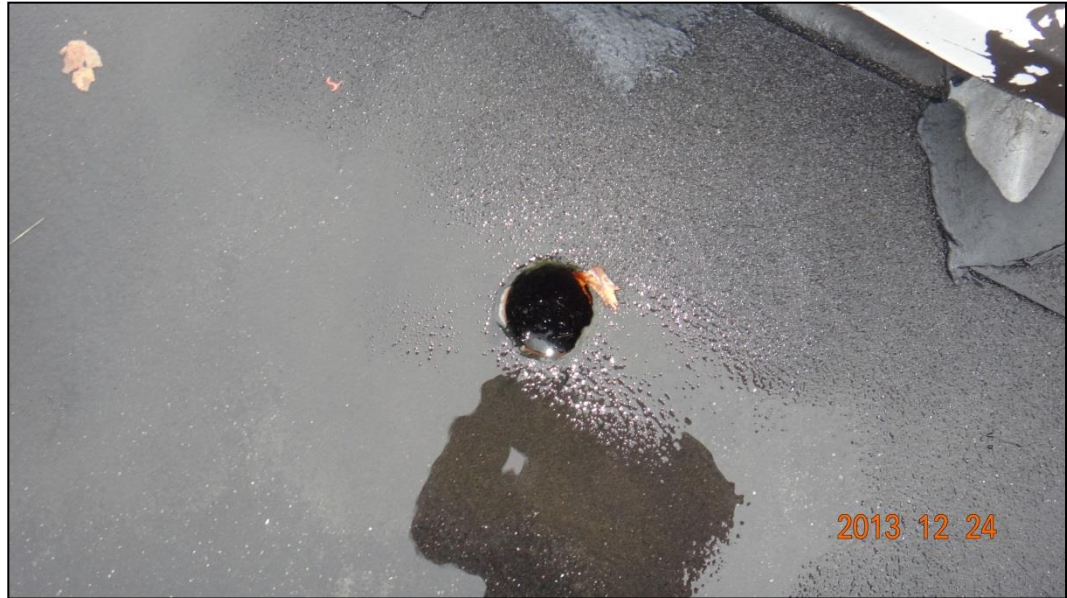
PHOTO #5 – *This photograph shows one of the roof drains without the grate to prevent debris from clogging the drain.*

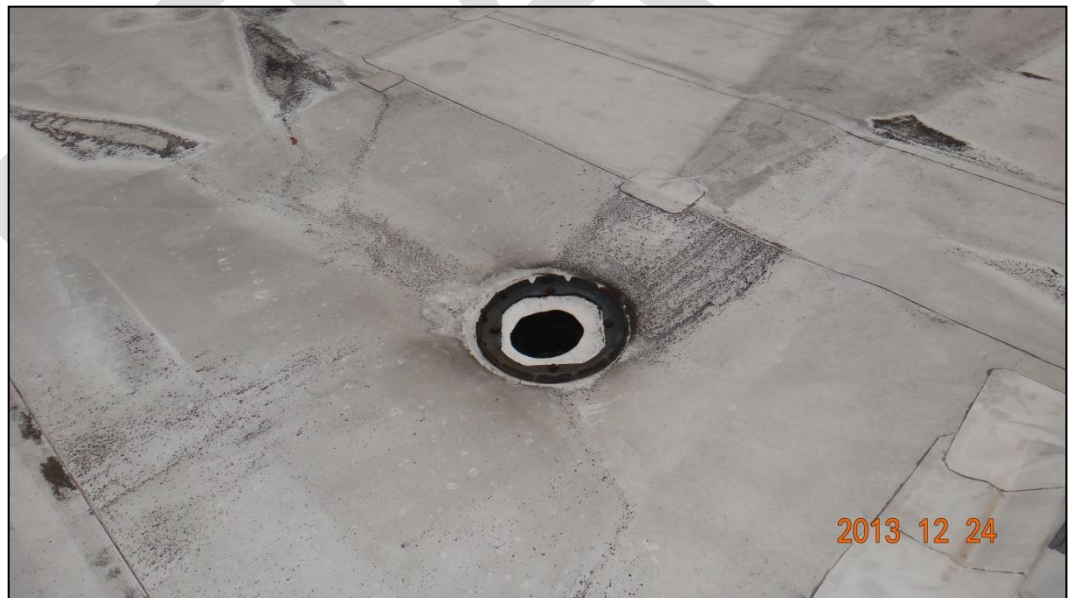
PHOTO #6 – *This photograph shows another of the many missing grates over a roof drain at the Dr. Edward A. Ricci Middle School building.*

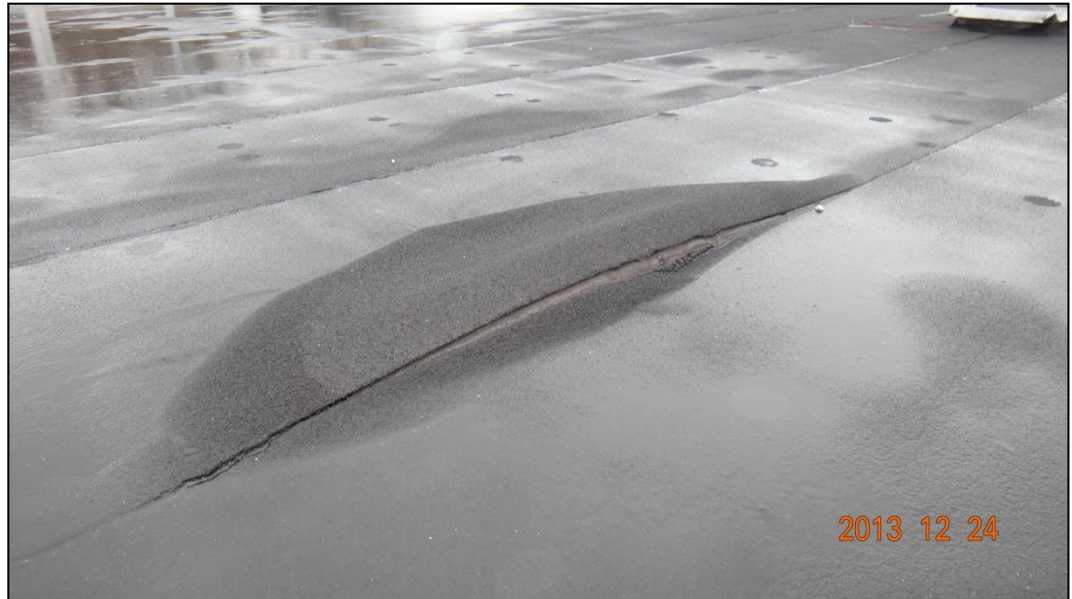
PHOTO #7 – *This photograph shows one of the many blisters in the rolled asphalt roofing membrane on the flat roofs of the Ricci Middle School building.*

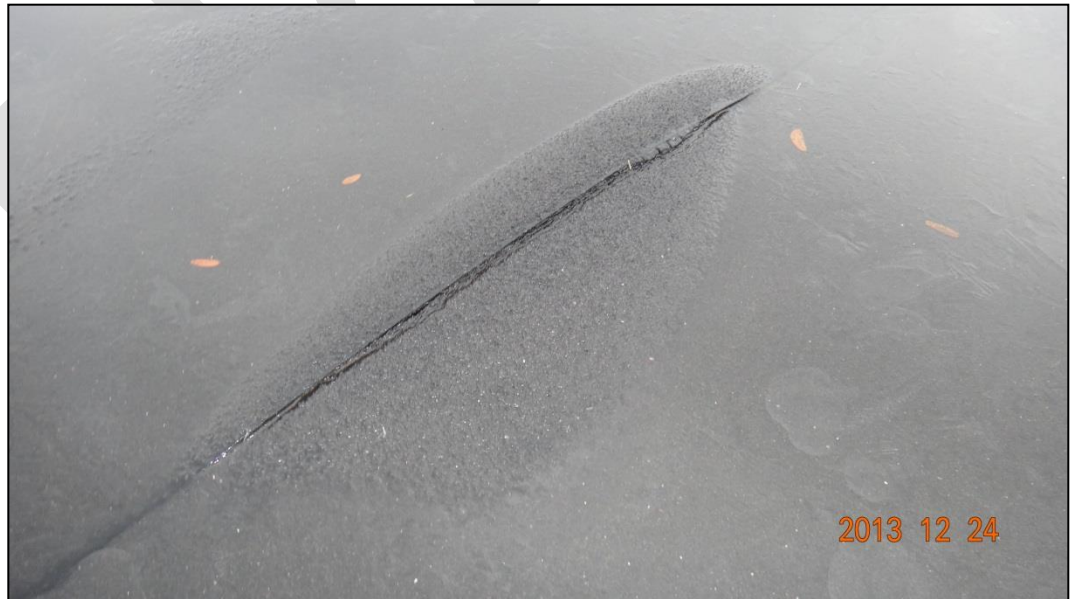
PHOTO #8 – *This photograph shows another of the blisters and a cracked seam of the rolled asphalt sheet roofing at the Ricci Middle School building.*

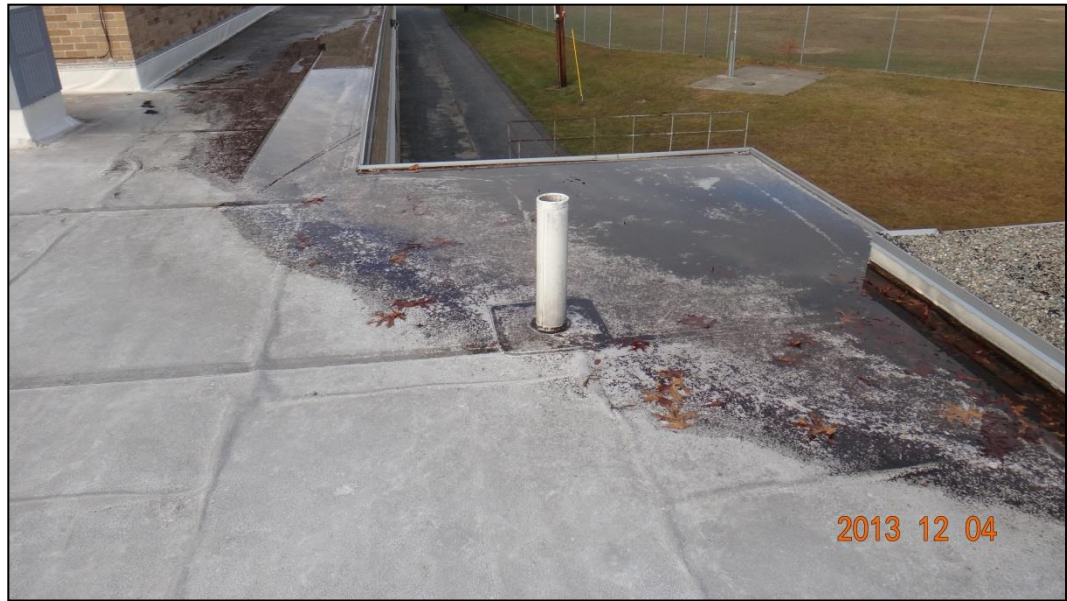
PHOTO #1 – *This photograph shows one of the areas where the water is ponding on the flat roof of the Birchwood Middle School building.*

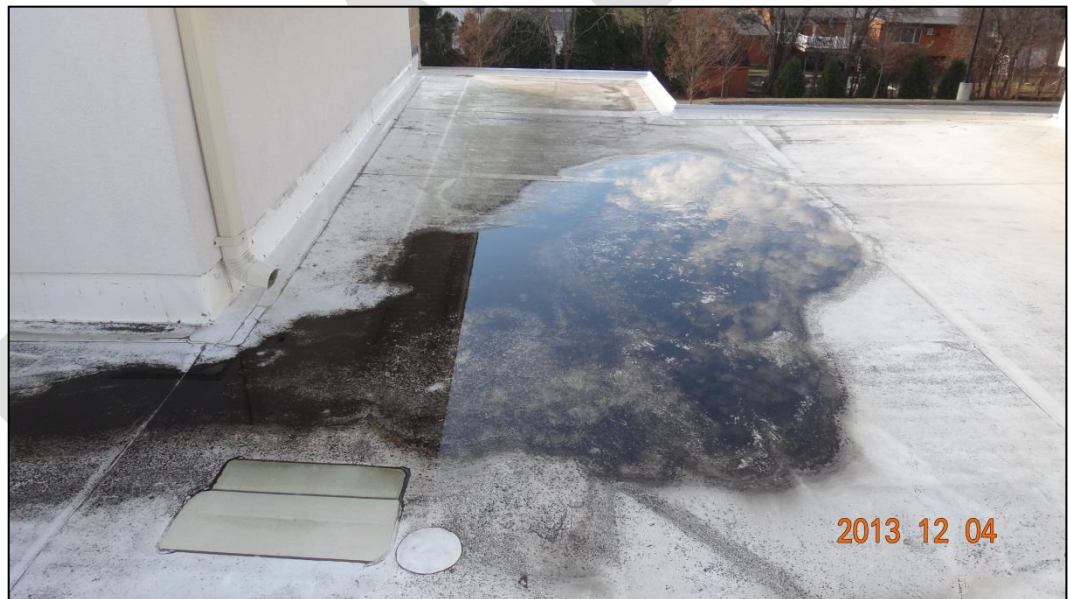
PHOTO #2 – *This photograph shows more ponding of water on the flat roof.*

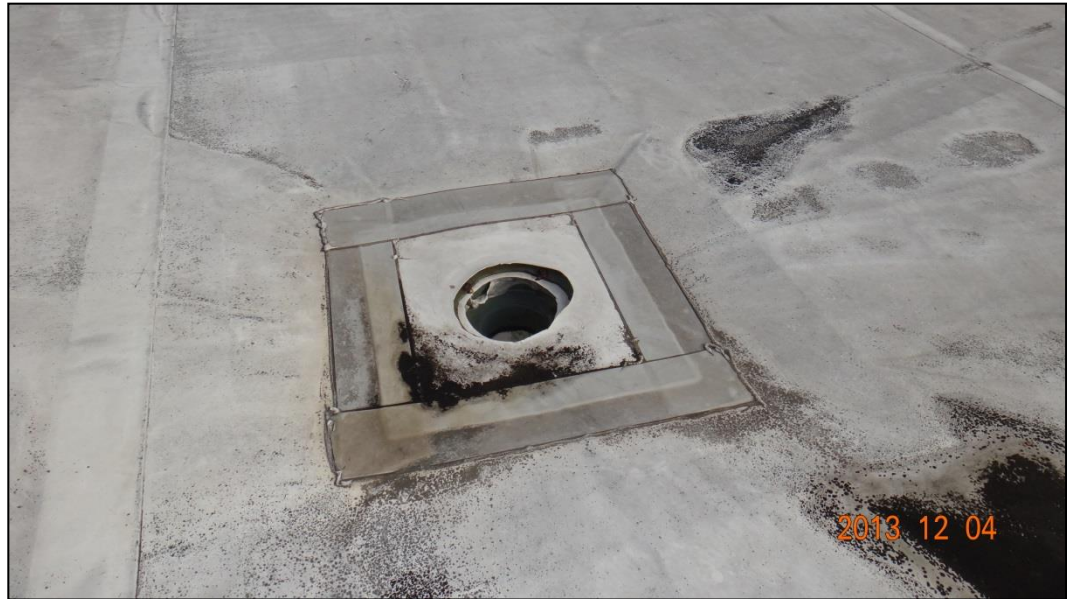
PHOTO #3 – *This photograph shows one of the roof drains without the grate to prevent debris from clogging the drain.*

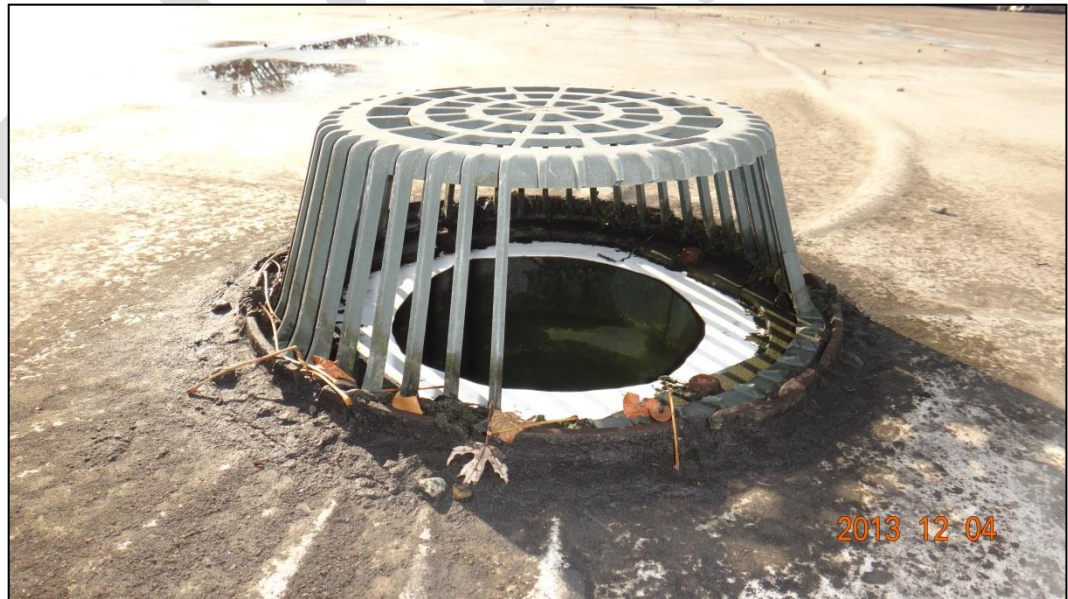
PHOTO #4 – *This photograph shows one of the damaged grates over a roof drain at the Birchwood Middle School building.*

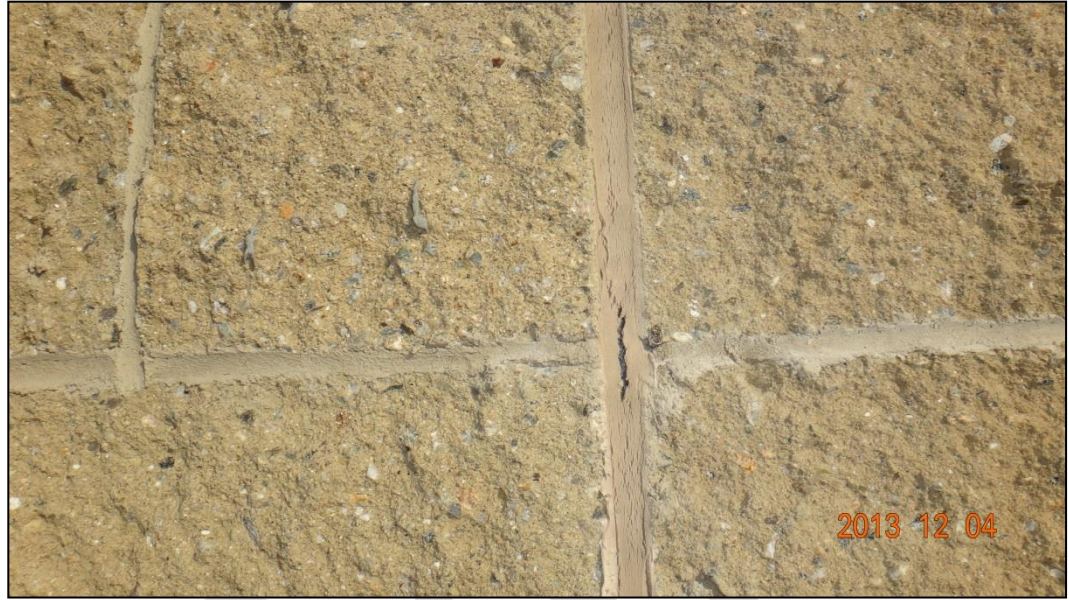
PHOTO #5 – *This photograph shows one of the locations where the exterior split-face masonry block joint sealant has cracked and failed.*

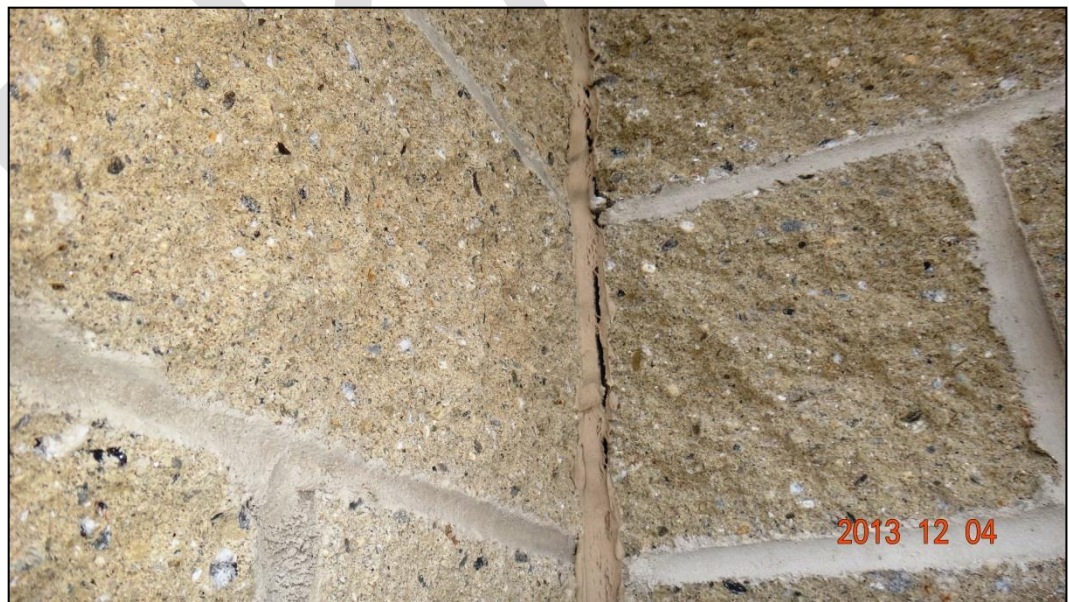
PHOTO #6 – *This photograph shows one of the locations where the joint sealant for the exterior wall split-face block joint sealant has lost the bond to the masonry block.*

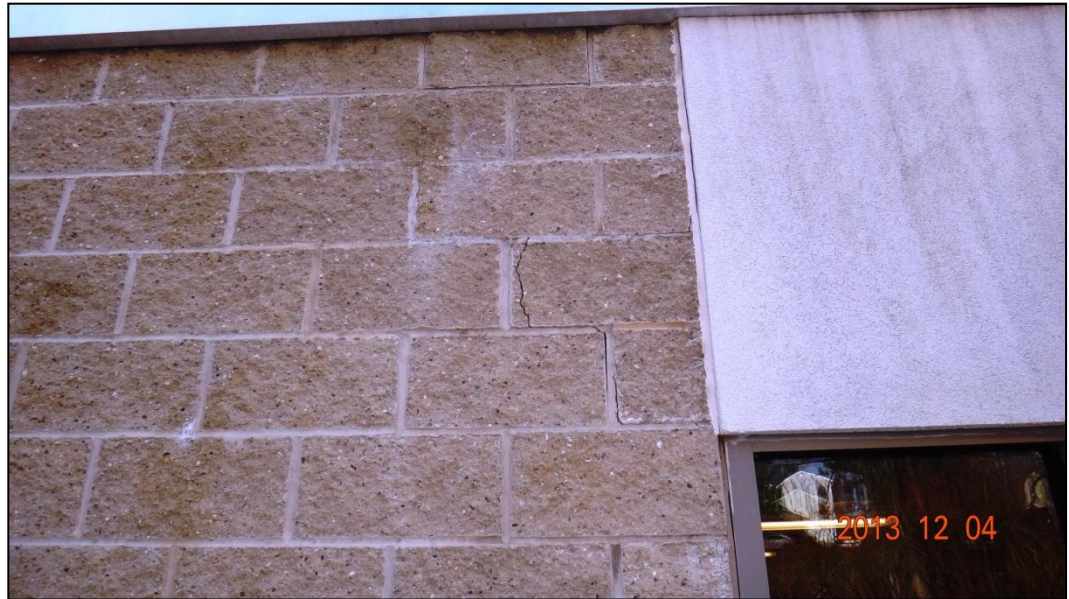
PHOTO #7 – *This photograph shows the step-cracking in the split-face block veneer located near the rear exit of the northeast wing of the Birchwood Middle School building.*
